Geotechnical Aspects of North Sea Decommissioning

XODUS
SUBSEA

Case Study

Hess Angus Piled Structure Removal

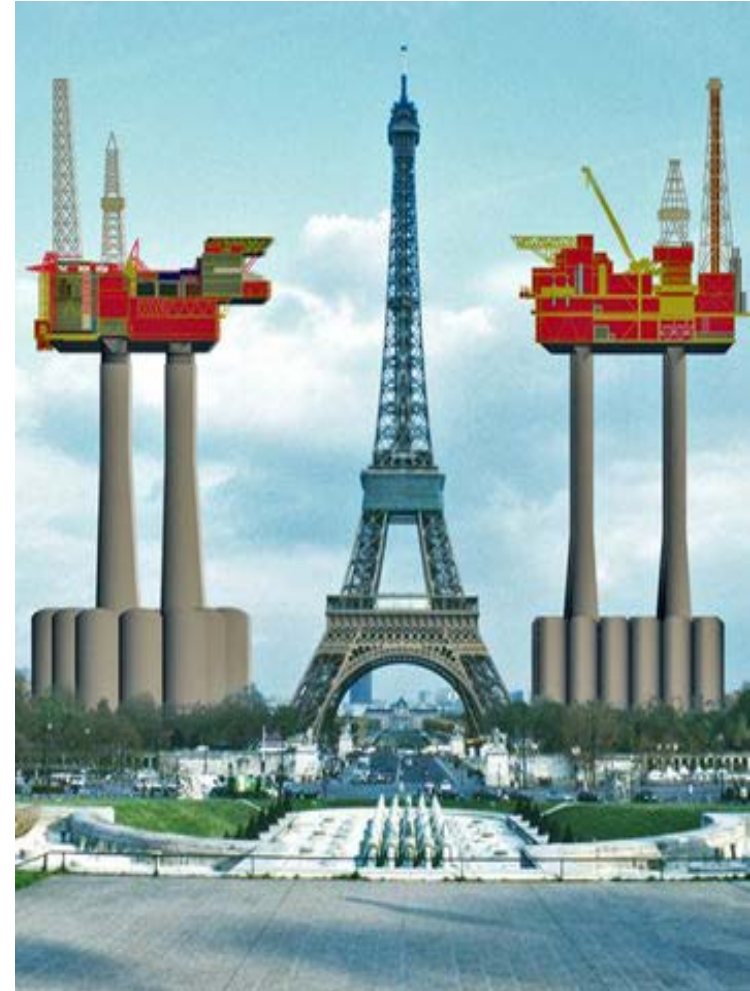
North Sea Decommissioning Market (UKCS)

- > Mature basin ~1968
- > ~300 undeveloped discoveries
- > 12% (88) of installations have been decommissioned e.g. jackets and floating
- > ~280 SPS and ~3000 pipelines / umbilicals
- > ~2% of pipelines have been decommissioned

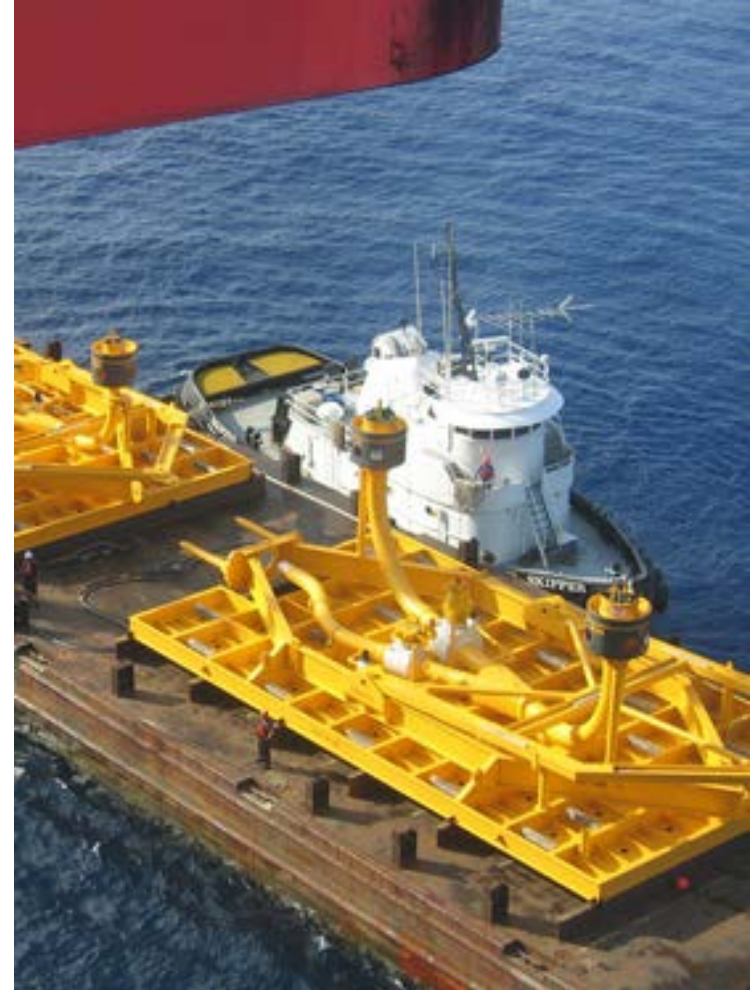
Subsea Structures and Moorings, Suction Caissons and Anchors

- > Designed for recovery?
- > Modular construction
- > Overpressure monitoring
- > Considerations:
 - Critical overpressures
 - Corrosion of piping
 - Piecewise deconstruction
 - Soil plug retained
 - Soil set-up
- > Contingencies:
 - External Dredging
 - Buoyancy
 - Rock dumping

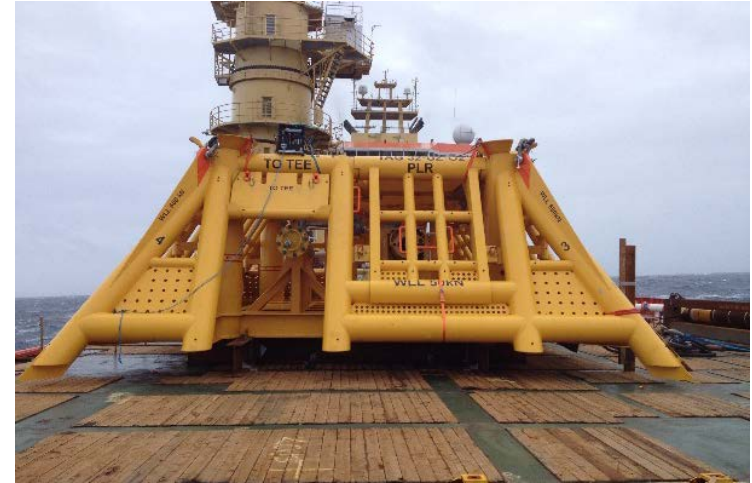
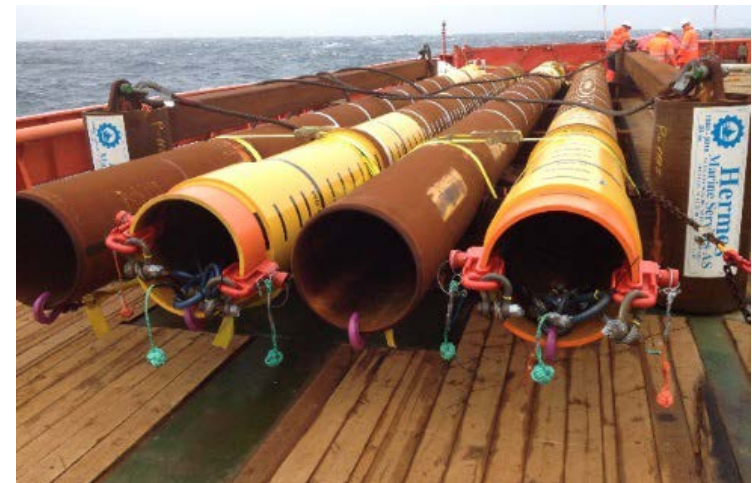
Subsea Structures and Moorings, Driven Piles

- > Typically 15-25m long piles Subsea Structures
- > Typically 40-50m long piles Moorings
- > Remove structure, cut piles below mudline
- > Internal / external cuts
- > Dredging options for cutting equipment
 - External large dredging
- > Possible to extract from seabed?
- > Possible seabed remediation works.

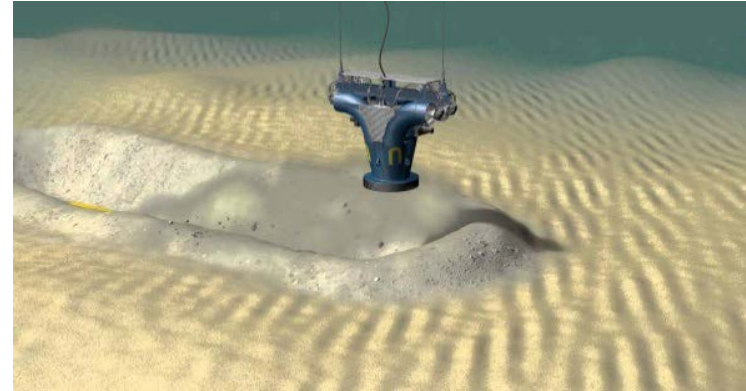
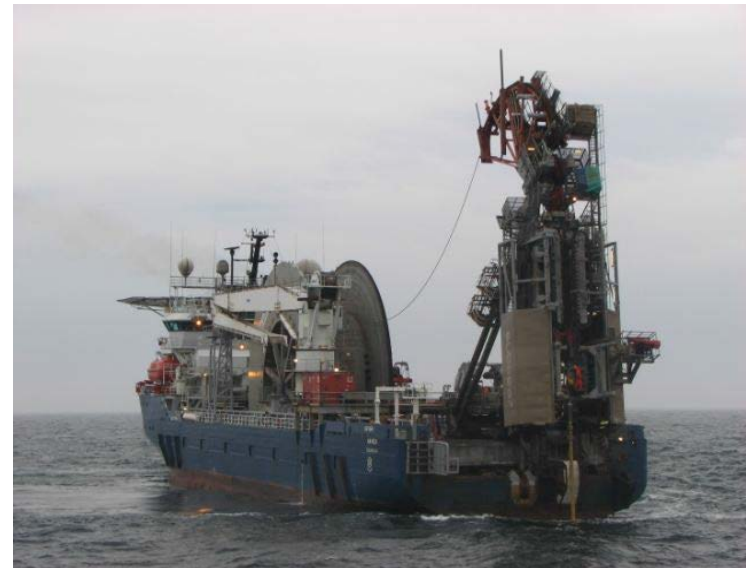
- > Pipeline Bundles Relatively unique to North Sea
- > Towheads (manifolds) connected to carrier pipe with multiple products
- > None have been decommissioned yet
- > Proposed removal options:
 - Reverse tow
 - Piece-wise deconstruction
 - Abandonment In-situ

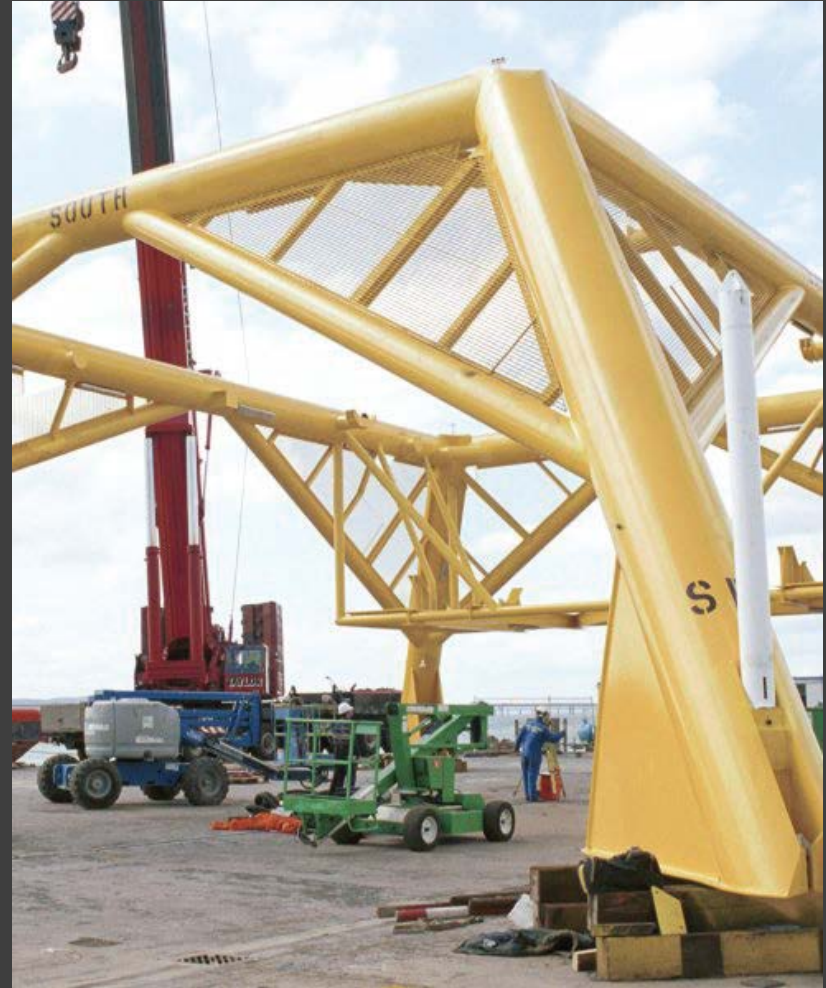
Structure geometry

- > 26m Length, 19.3m wide, 8m high

Pile geometry

- > 4 A-shaped piles
- > Length 7.4m, breadth 3.0m

Geotechnical conditions

- > Holocene veneer over medium dense to dense sand

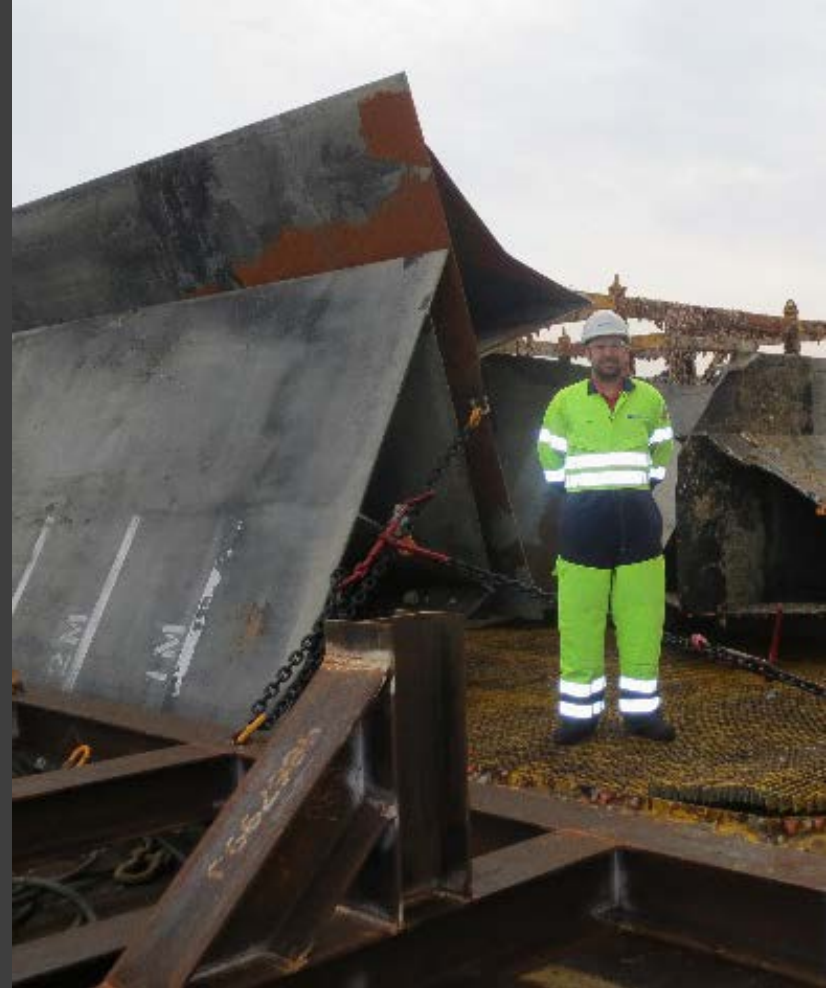
Hess Angus Piled Structure Removal – Deconstruct Sequence

- > Exploit modular construction
- > Piecewise deconstruction
- > Full pile removal

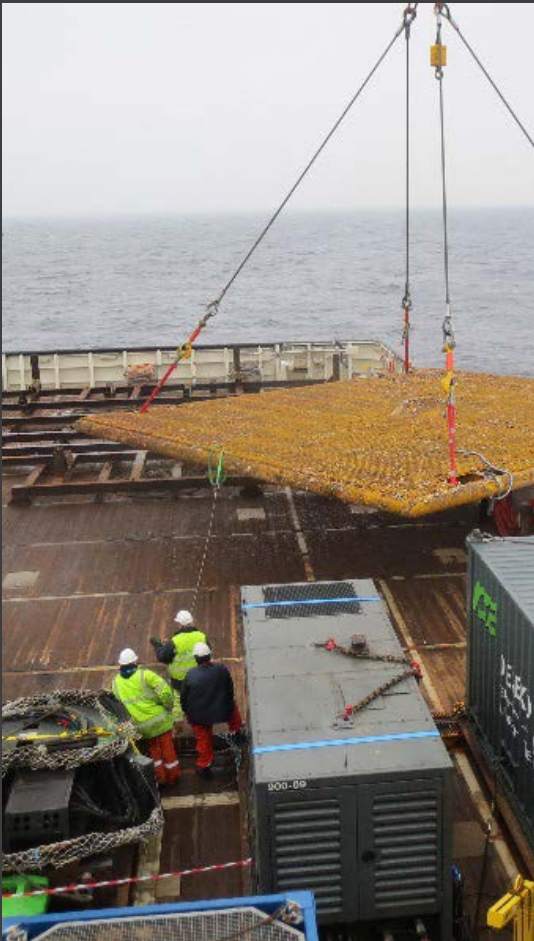
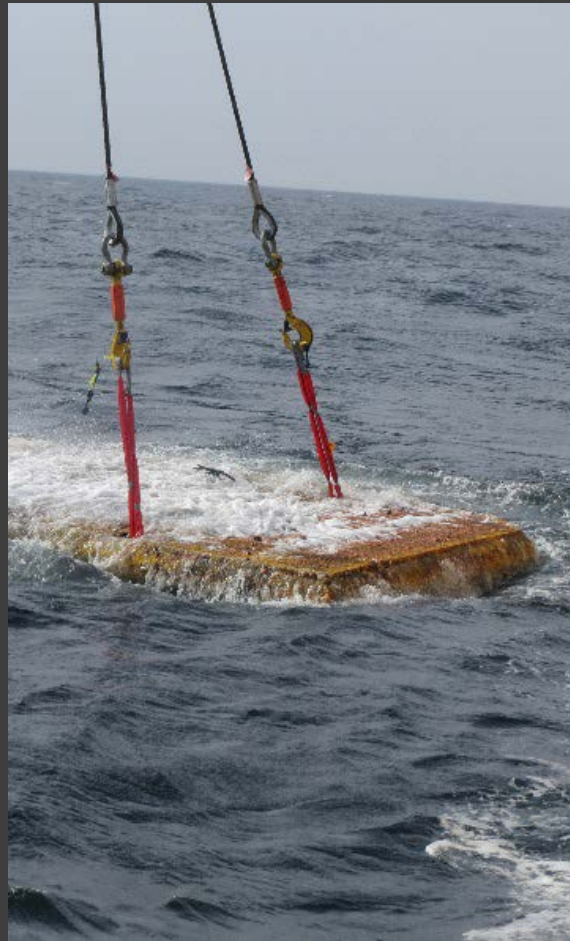
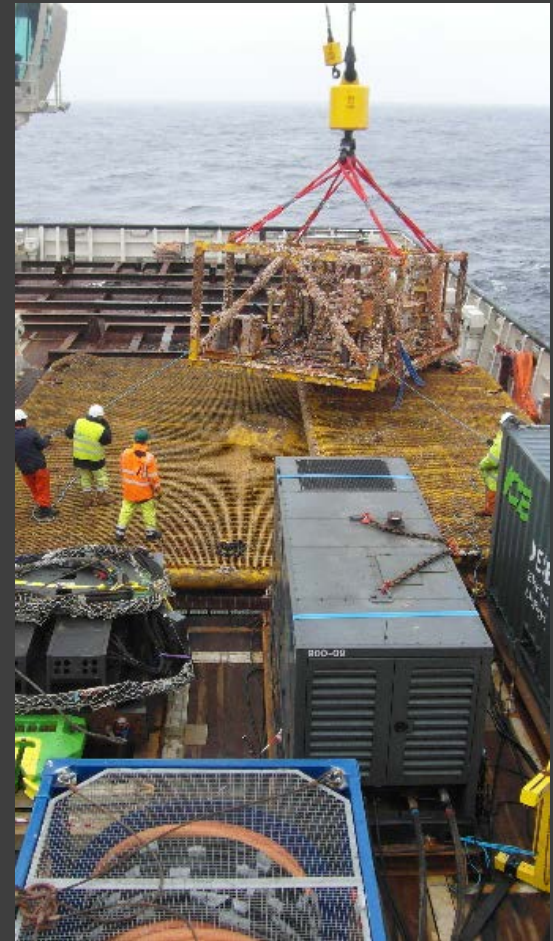
> Roof panels and SCM recovered

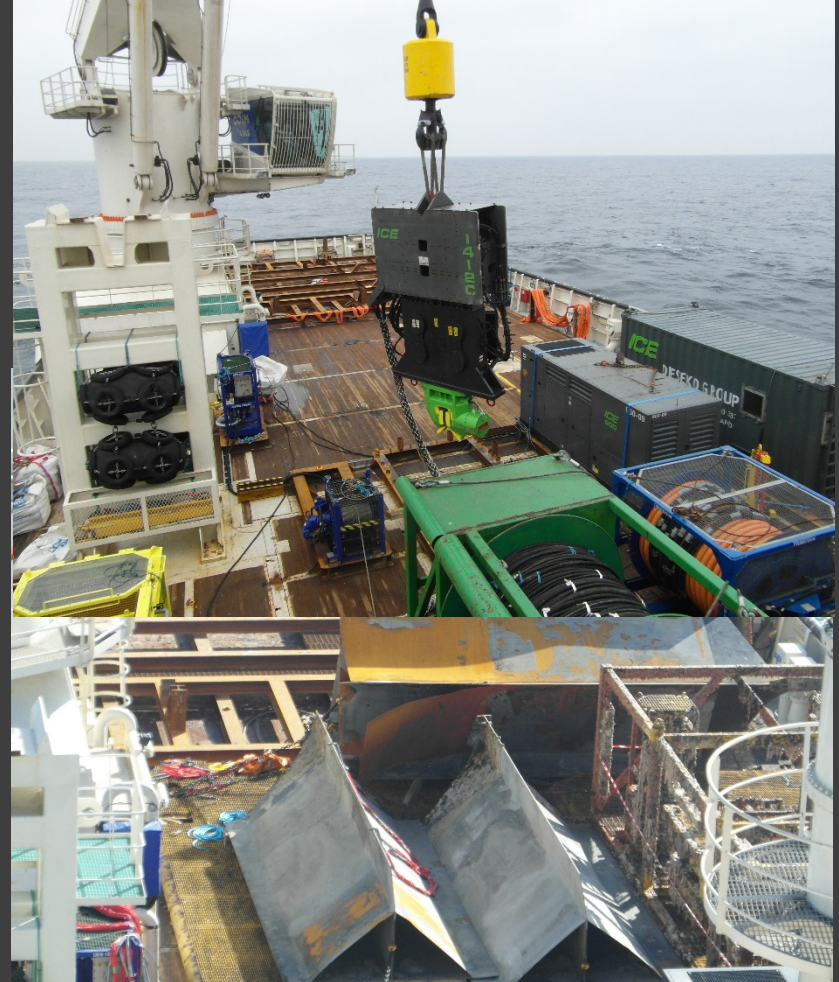
Hess Angus Piled Structure Removal – Deconstruct Sequence

- > Structure cut from footings
- > Lifted off footings and flipped
- > Leg stumps recovered
- > Piles recovered
- > Structure cut in half

- > 3 of the 4 piles were recovered with very little tensile uplift
- > 1 pile required a further 20Te of uplift
- > 5 to 19 mins to vibration with 20Te of uplift applied (pile + vibrohammer + clamps + rigging)
- > Secondary cut locations had to be adopted due to the vibrations induced in the structure
- > 6 days from start to completion of offshore operations

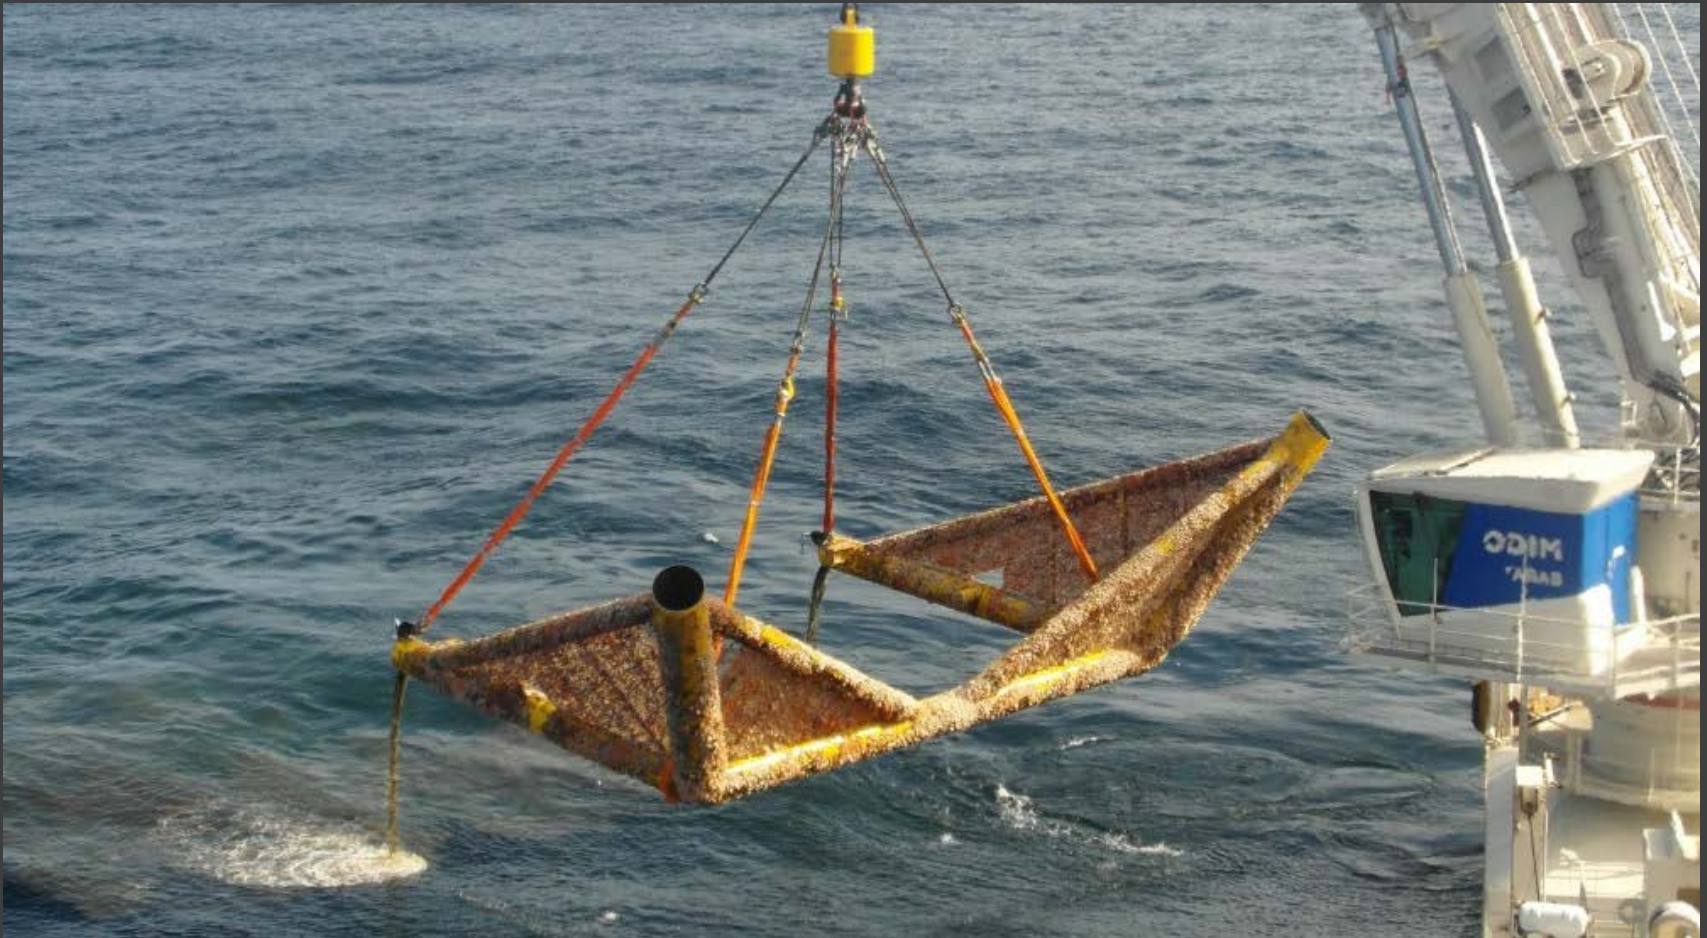
Hess Angus Piled Structure Removal – Deconstruct Sequence

- > South section recovered

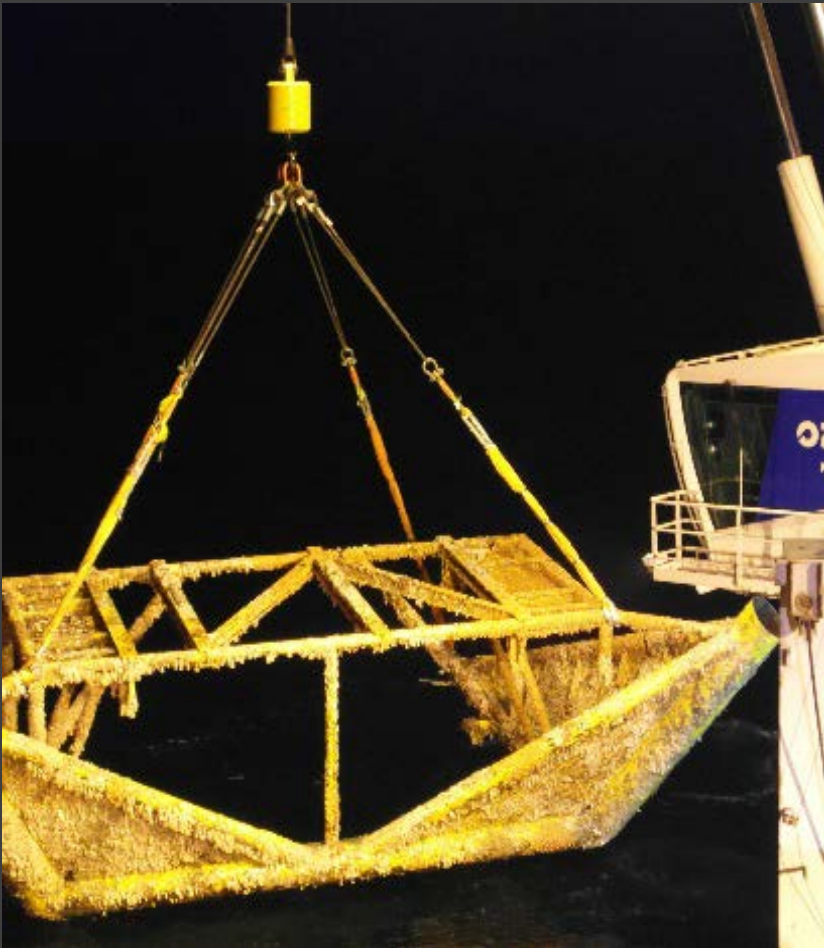
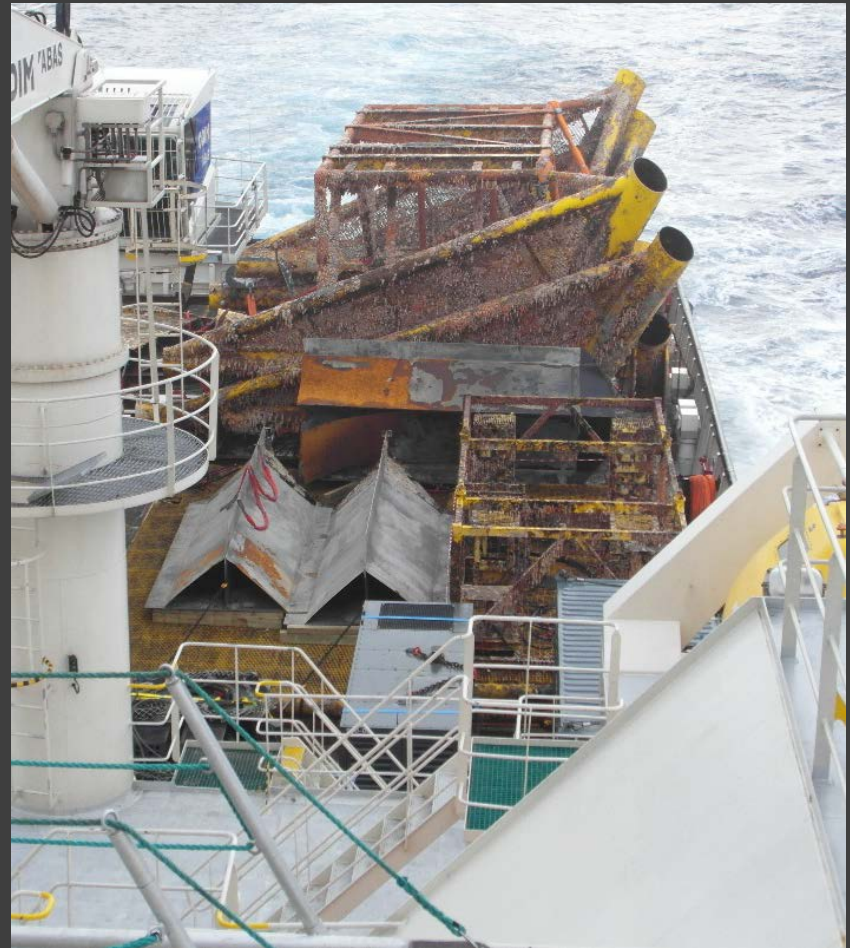
Hess Angus Piled Structure Removal – Deconstruct Sequence

- > North section recovered placed in South section
