Composite Caisson Repair

Overview
<p>Our client operates a large facility Offshore UKCS and had detected serious levels of corrosion / erosion and thru wall penetration in a large multi diameter seawater caisson. Previous attempts to return the caisson integrity had failed and the caisson remained in a substandard condition, with the potential for a large section of the caisson to fully detach from the main assembly.</p> <p>In addition to arresting any further material loss, the client urgently required to affect a caisson repair that would return the caisson integrity in line with platform unity requirements.</p>

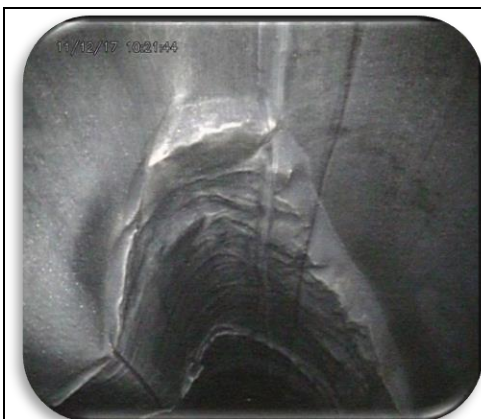
Image shows liners flexibility (coating over grout)

Cape developed a flexible composite liner which deployed from the topside access point and coated the caisson well below all identified defects. A Hydrophobic resin was infused into the liner which expelled water / moisture between liner and caisson bore below sea level, allowing the material to bond along the full length.

The liner is inflated to take up the profile of the various caisson bores / grout etc and once cured, created a uniform bore down the caisson, filling thru hole penetrations and bonding to remaining caisson bore material preventing further internal corrosion of parent material.

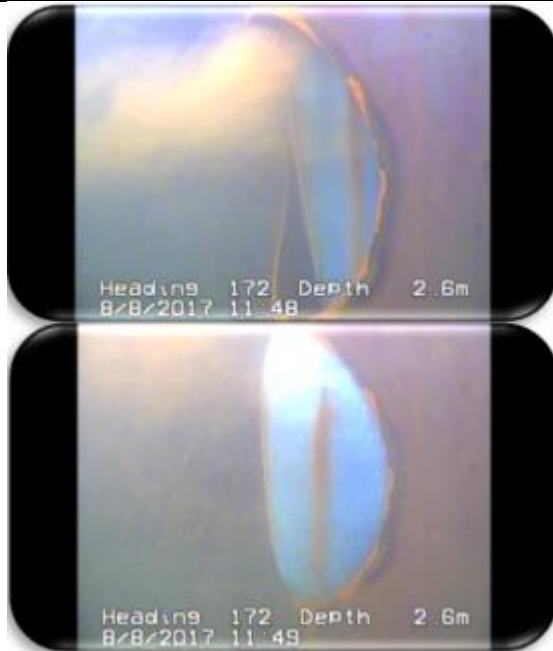
Images shows liners ability to return integrity

The resultant repair returned the caisson back to a unity position and allowed its return to operation. While internal corrosion has been arrested, external corrosion will continue to be monitored to assure caissons unity position.
