New P&A Technologies and Techniques Verification of Natural Barriers

Schooner Decommissioning Project

Chris McIlroy Well Abandonment Engineer

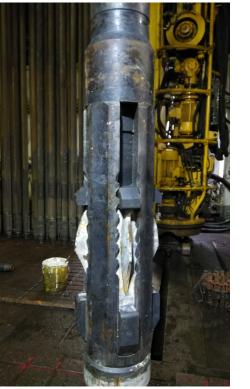
- Casing perforations required to apply a pressure test to the annulus
- Gator tool selected
- Perforations made either side of creeping formation

113/4 CASING 825 - HWG -005 MAX 00 - 13 1/8" WIDTH HEIGHT LENGTH PSI To 647 - 1330
