TACTT – TA Cap Test Tool

TACTT – What is it?

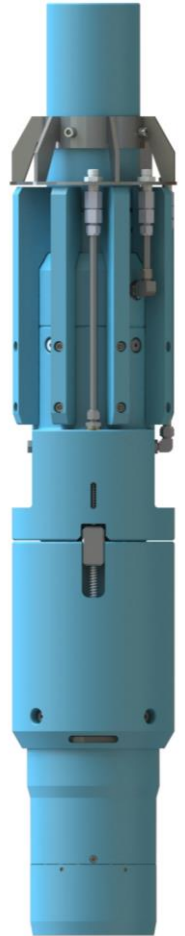
- Drill Pipe or Vessel deployable system, that allows testing and (limited) venting of trapped pressure below mudline suspended Temporary Abandonment (TA) caps with BPV's fitted.
- Facilitates the pressure test of deployed seals, prior to stabbing the BPV (5,000 psi capable).
- Allows controllable stabbing of the BPV, with ability to verify that the valve has been stabbed/opened.
- Provide means of leaving a secondary check valve assembly in place should the original not re-seat.

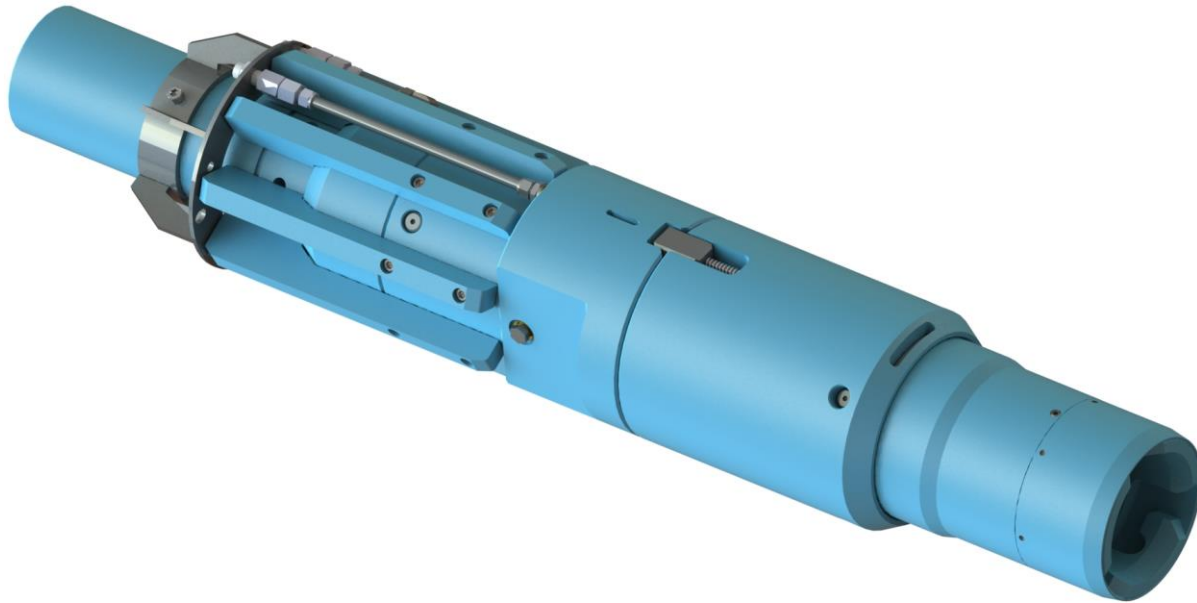
TACTT – Deployment Overview

1. Latch on to TA Cap and confirm engagement with over pull
2. Pressure test to test integrity of seals
3. Stab the TA cap back pressure valve and monitor for pressure build up
4. If there is no pressure; retract the piston and retrieve TACTT to surface
5. If pressure is found; leave bottom section of TACTT in place as additional barrier

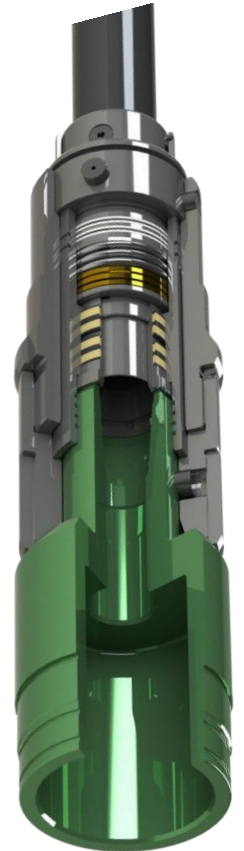
TACTT Mk. 1 – Retrieved TA Cap

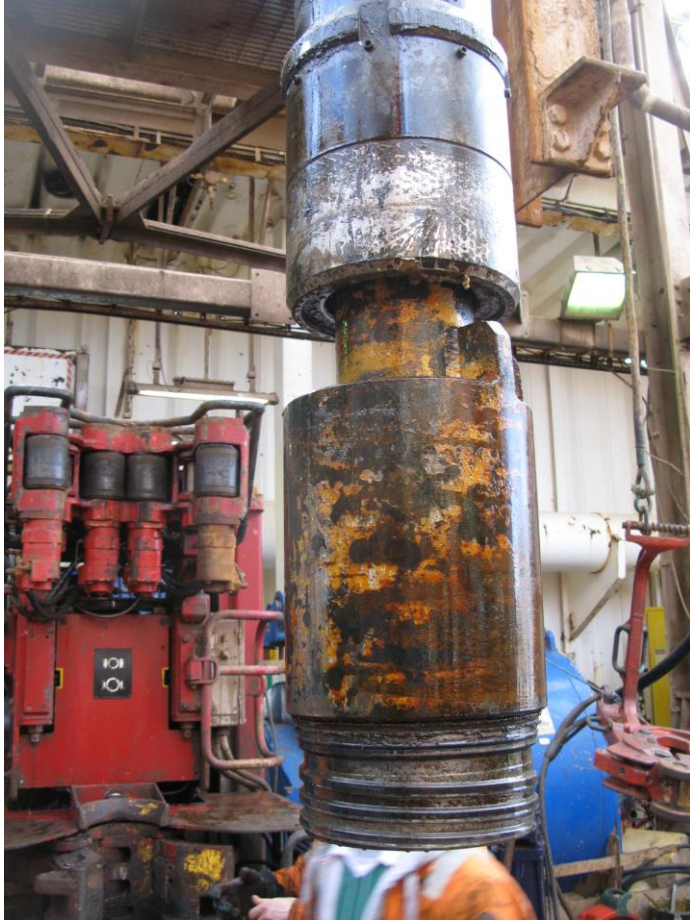
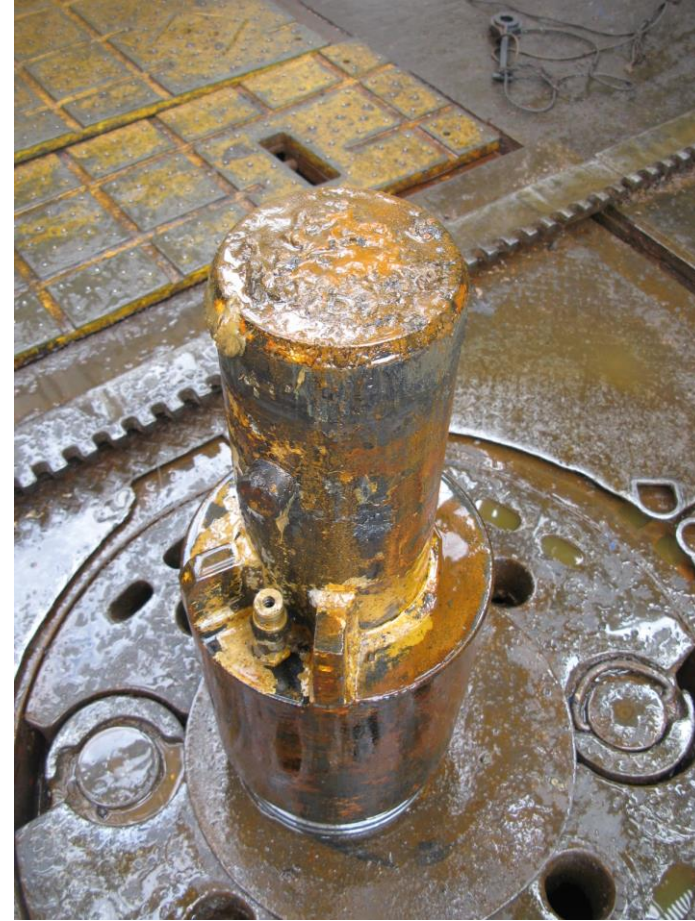
- Tool worked well and as expected, 4,000 psi seal obtained with no sealant required.
- Centralisation (or lack of) can make all the difference!
- DH Camera's worth every penny!
- Retrieved BPV was tested in Unity's workshop to verify operation. The BPV did **not** reseal once stabbed, validating the initial concern that it would not reseal once disturbed.
- Based on the success of the TACTT Mk1, Spirit subsequently asked Unity to develop a system for vessel deployment.

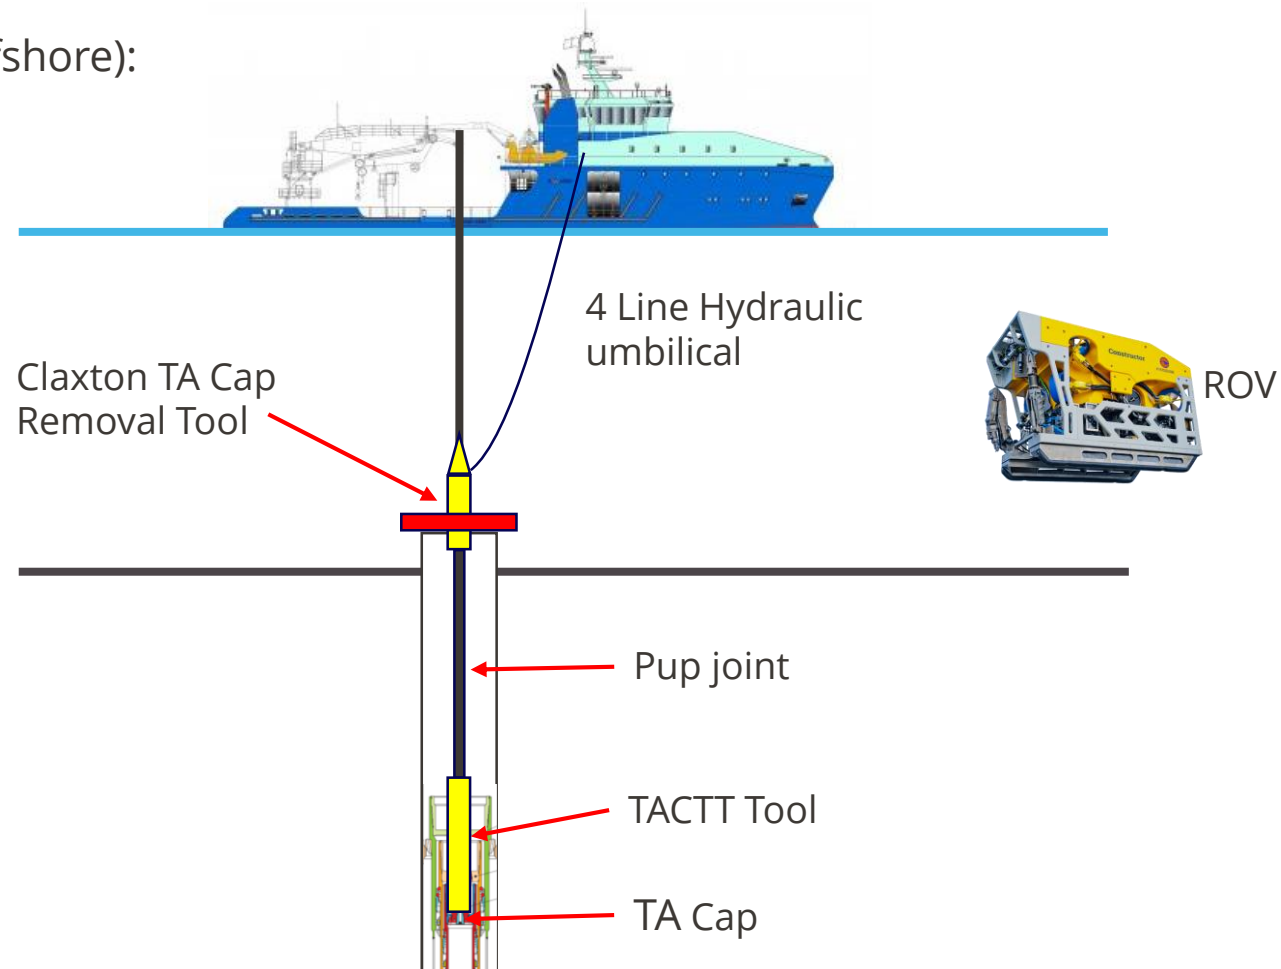
Rig-up and deployment (offshore):

- Tool worked well and as expected, 4,000 psi seal obtained.
- No pressure found below cap.
- Some improvements noted to make deployment more efficient.
 - Improved Control Panel Design
 - More robust interface between umbilical and TACTT

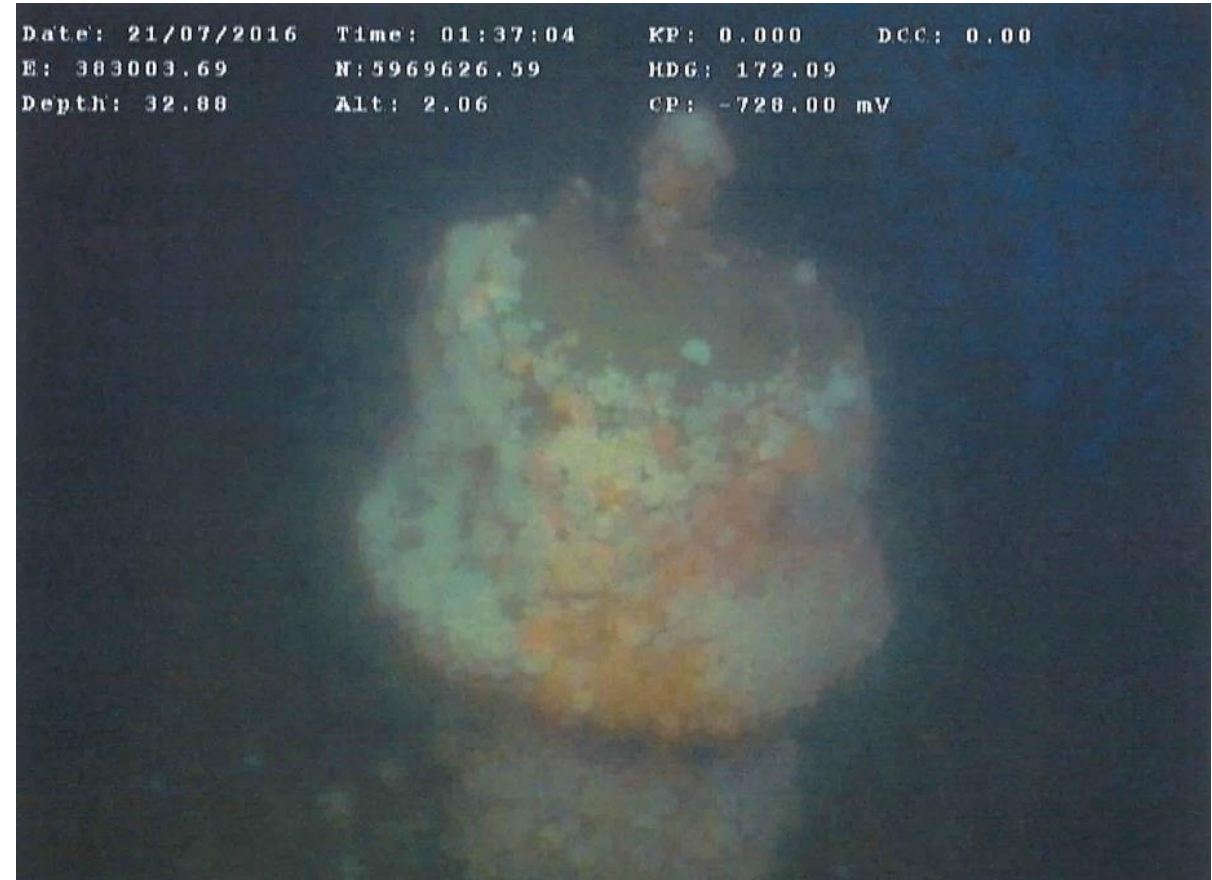
- August 2019
- North Sea - Babbage field
- Deployed from AHTS / Light Construction Vessel
- DQ MS15 9-5/8" Cap
 - Suspended in 1984
 - Water depth – 114 ft.
- Pressure test requirement 5,000 psi

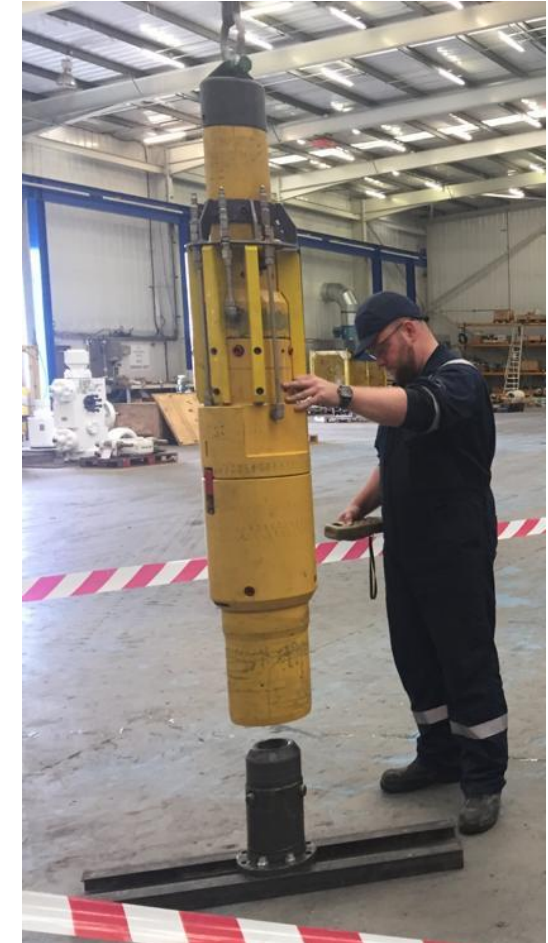
Case Study – InterMoor - SIT

- SIT requested after modification of TACTT
- Simulated running procedure:
 1. Engaged with 9 5/8" TA Cap and confirmed with over-pull
 2. Pressured up TA Cap to simulate well conditions
 3. Stung TA cap and monitored pressure
 4. Simulated leaving secondary BPV in-situ
 5. Re-engaged secondary BPV and disconnected from TA Cap

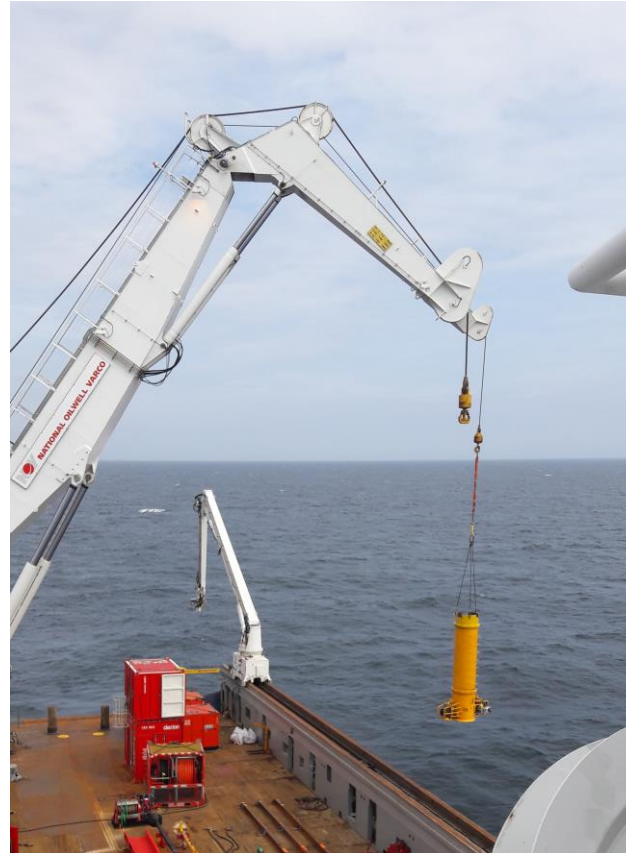
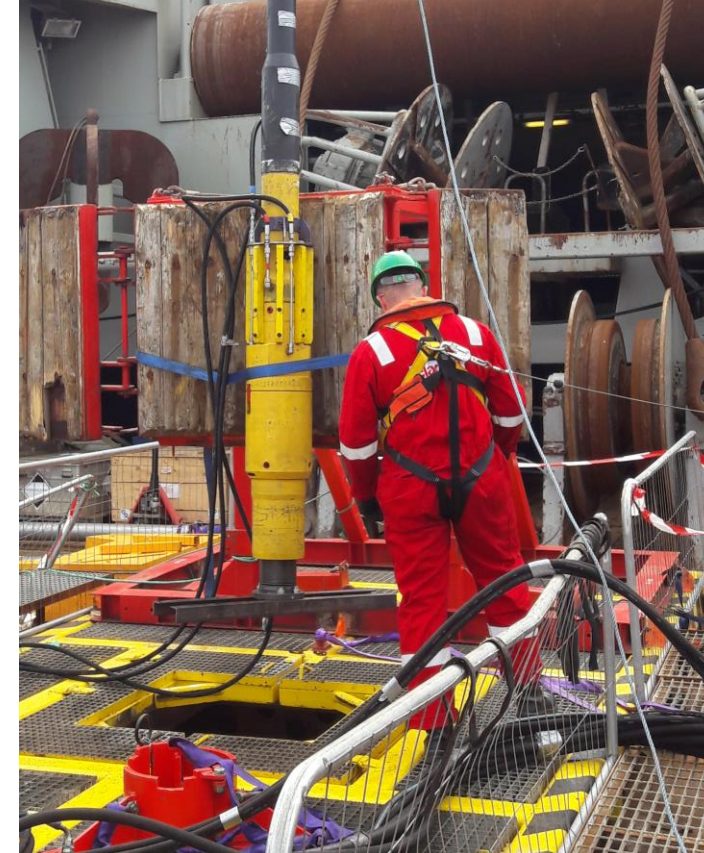
Case Study – InterMoor – Offshore Operations

- Reaction can deployed onto conductor
- Rotary connected to Unity TACTT. On deck pressure test with test TA cap prior to deployment. This confirmed integrity of the stack up
- Rotary and Unity TACTT deployed through moon pool using vessel crane

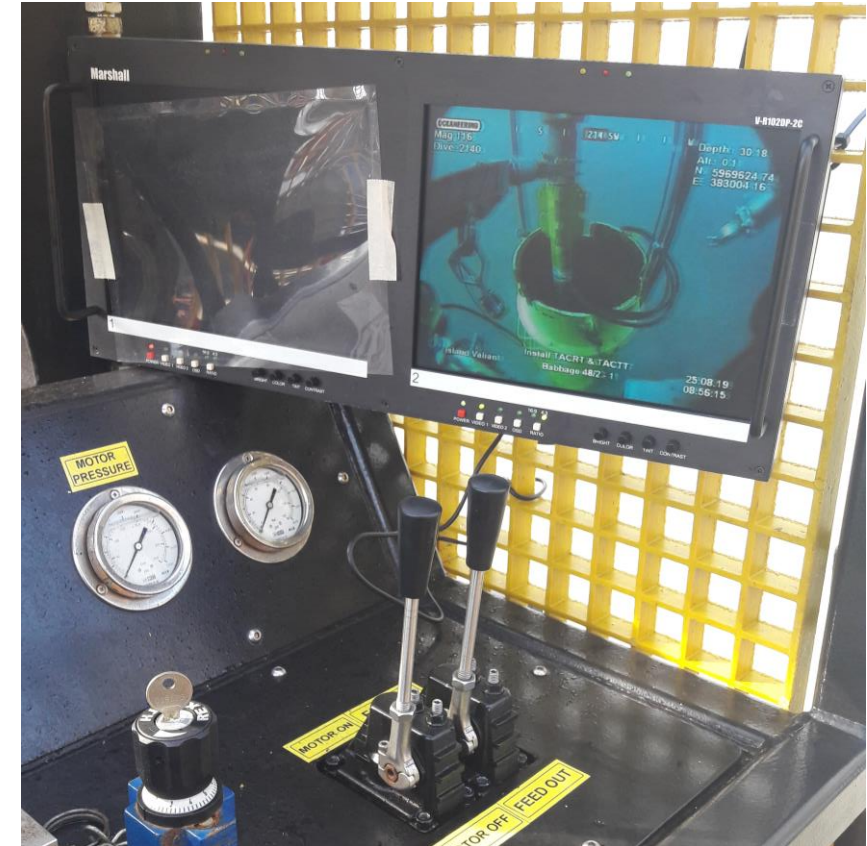
Case Study – InterMoor – Offshore Operations

- ROV used to manipulate TACTT and umbilical as the assembly was lowered through reaction can.
- The TACTT was rotated anti-clockwise until a physical drop of the tool was observed. A clockwise rotation was made until a pressure build up was detected. An over pull on the crane confirmed the tool was latched.
- The assembly was pressured up to confirm seal integrity against TA Cap.
- The TA cap was stung. No pressure was recorded.
- TACTT disengaged from TA cap and returned to deck

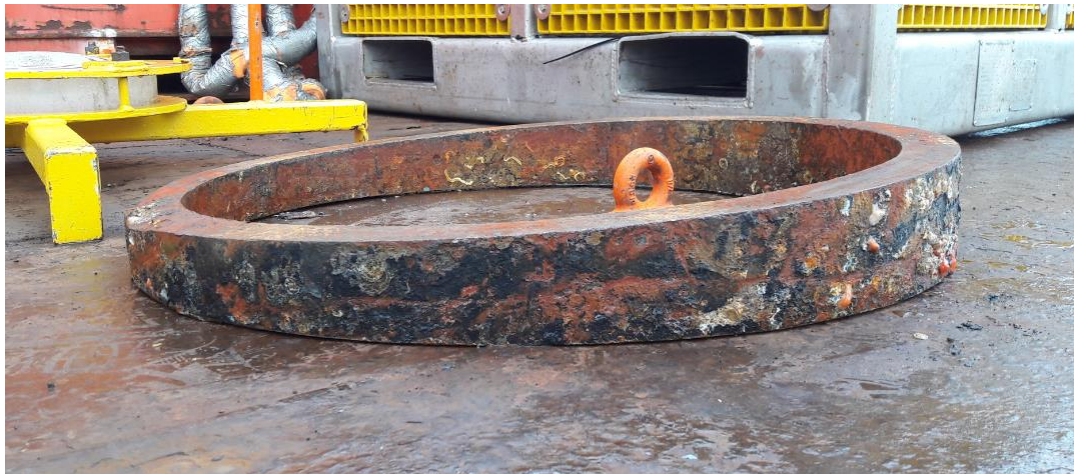
InterMoor –Lessons Learned

- The top of the conductor was at an angle in the “as found” condition
 - For vessel based deployments, it is important that the top of the conductor is as parallel as possible.
 - 9 5/8” tolerances were close and the angle made it difficult to locate the tool and latch on to the TA Cap.
