Decom Offshore 2020 Decommissioning Project Execution 27 August 2020

BiSN's Wel-lok M2M technology

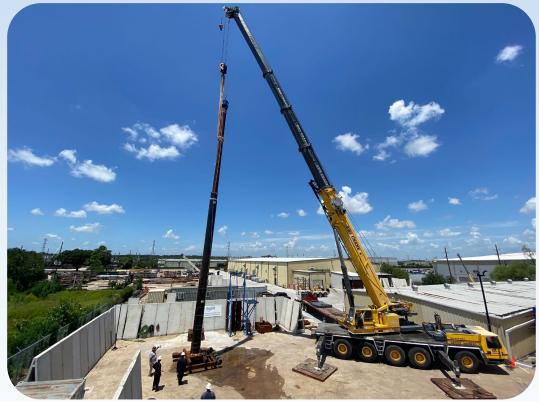
Material characterization to be accepted as a barrier by local regulatory group (PSA)

- Aker BP to use BiSN as "alternative" barrier for environmental plugs
 - **13 3/8" x 20"**
 - **18 5/8" x 24"**
 - **20" x 30"**
- $\circ~$ BiSN conducted extensive testing over 3 $^{1\!\!/_2}$ years

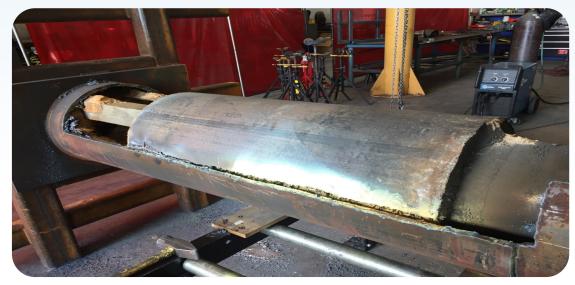
Wal-lok M2

- Plug set in September 2018
- $\,\circ\,$ 13 3/8" casing section milled out to 18 5/8" casing
- 18 5/8" casing perforated below plug in a known shallow gas zone to ensure BiSN plug would see gas pressure / bubbles
- $\,\circ\,$ No pressure or bubbles seen above plug for 23 months
- $\,\circ\,$ Gauges installed below BiSN to measure pressure over 2-year period
- $\circ~$ Plug to be milled out next month to retrieve gauges and evaluate data
