North Sea Platform - Chemical descale, produced water system

Client	North Sea Platform
Project	Chemical descale of a produced water system
Location	North Sea
Size of Contract	Compact project

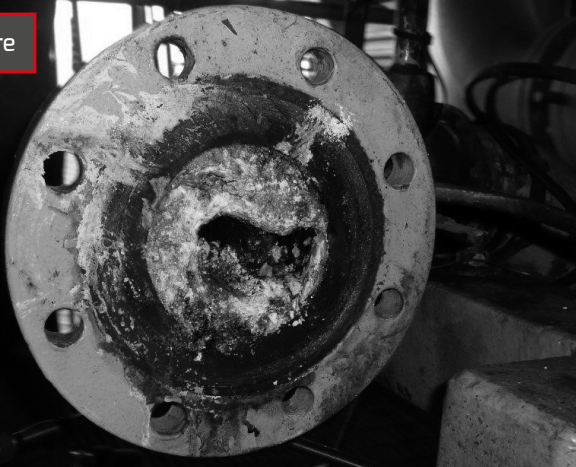
Before

A platform out in the North Sea was experiencing production problems. It was noted that the flare scrubber lines and closed drains had been contaminated by scale which had reduced the internal pipe diameter by almost 60%.

The task was to remove the scale by using a CEFAS approved chemical. To remove this fouling, a decision was made to clean the flare scrubber lines first then the closed drains. Following emergency meetings, we produced schematic drawings of our equipment hoses and connections with a corresponding time schedule of work.

Altrad Services produced method statements for each stage which were accepted by the client, after which the equipment was mobilised to the platform. With full assistance of the operations, the platform was isolated and ready for our first descale on the flare scrubber. This went very well, with the work being delivered safely and on time, and the platform was able to produce again. Working on one train at a time, Altrad Services managed to descale the closed drains pipework with various loops and back flushes. An emersion bath was also conducted to descale items removed by the maintenance team from other parts of the plant. The scope of work was completed safely, over a ten day period, which was commended by the client.

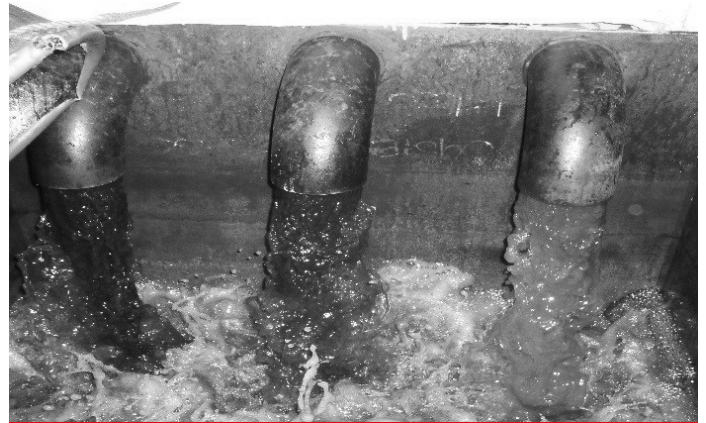
Flows from various system sectors showing progressive change in cleanliness
