MEMBERS' PORTAL CASE STUDY

COSTA CONCORDIA – WRECK REMOVAL

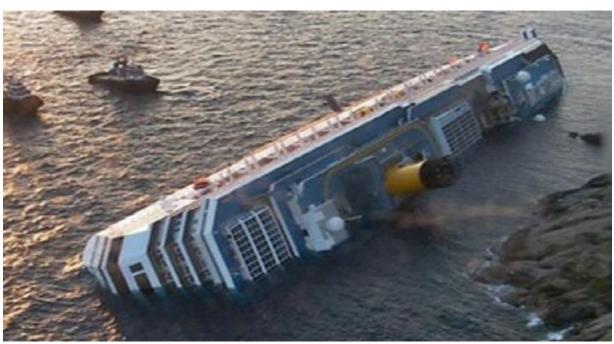
To begin, Ardent created metal patching to prevent further tearing and then attached sponsons to increase buoyancy and help with stabilization. To right the vessel, a parbuckling system utilizing 32 strand jacks was used. Once the vessel was parbuckled, additional sponsons were attached to the starboard side and the vessel was refloated. The vessel was then towed using 2 tugs and 6 escort vessels.
